**DEPARTMENT OF TRANSPORTATION**

Contract #: 04-0120F4Cty: SF/ALA Rte: 80 PM: 13.2/13.9File #: 69.28**WELDING INSPECTION REPORT****Resident Engineer:** Pursell, Gary**Address:** 333 Burma Road**City:** Oakland, CA 94607**Report No:** WIR-001327**Date Inspected:** 23-Jan-2008**Project Name:** SAS Superstructure**OSM Arrival Time:** 1800**Prime Contractor:** American Bridge/Fluor Enterprises, a JV**OSM Departure Time:** 700**Contractor:** Zhenhua Port Machinery Company, Ltd (ZPMC), Changxing Island **Location:** Shanghai, China**CWI Name:****CWI Present:****Yes No****Inspected CWI report:** **Yes No N/A****Rod Oven in Use:** **Yes No N/A****Electrode to specification:** **Yes No N/A****Weld Procedures Followed:** **Yes No N/A****Qualified Welders:** **Yes No N/A****Verified Joint Fit-up:** **Yes No N/A****Approved Drawings:** **Yes No N/A****Approved WPS:** **Yes No N/A****Delayed / Cancelled:** **Yes No N/A****Bridge No:** 34-0006**Component:** Tower mock up assemblies**Summary of Items Observed:**

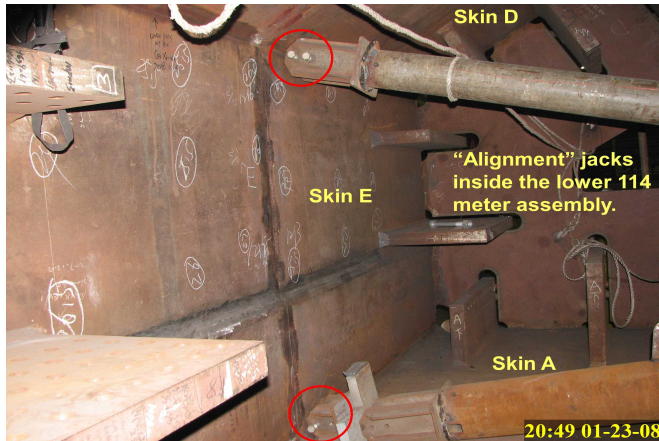
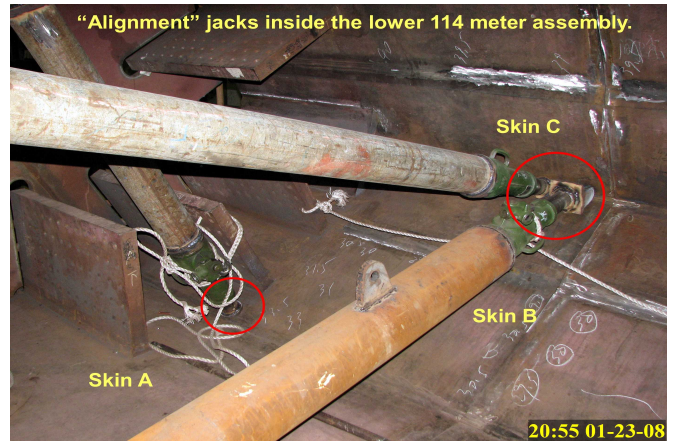
The QA inspector noted that the jacks that are being used for as alignment aids are placed against opposing welds of the pentagon shape of the assembly and are being held in place by force. The QA inspector is not aware of how much force is being applied with the jacks and the QA inspector is not aware of the condition of the contact surfaces under the jacks. At the time of the QA inspector's 10% UT verification, joints MWT-70, MWT-71 & MWT-73 appeared to be conforming to the requirements of AWS D1.5 2002 Table 6.3. See the attached photos of the jacks in place inside the Lower 114 meter tower mock up assembly.
